Geomorphology & Engineering survey

Site assessment and VT tools

Assessment and Design Overview

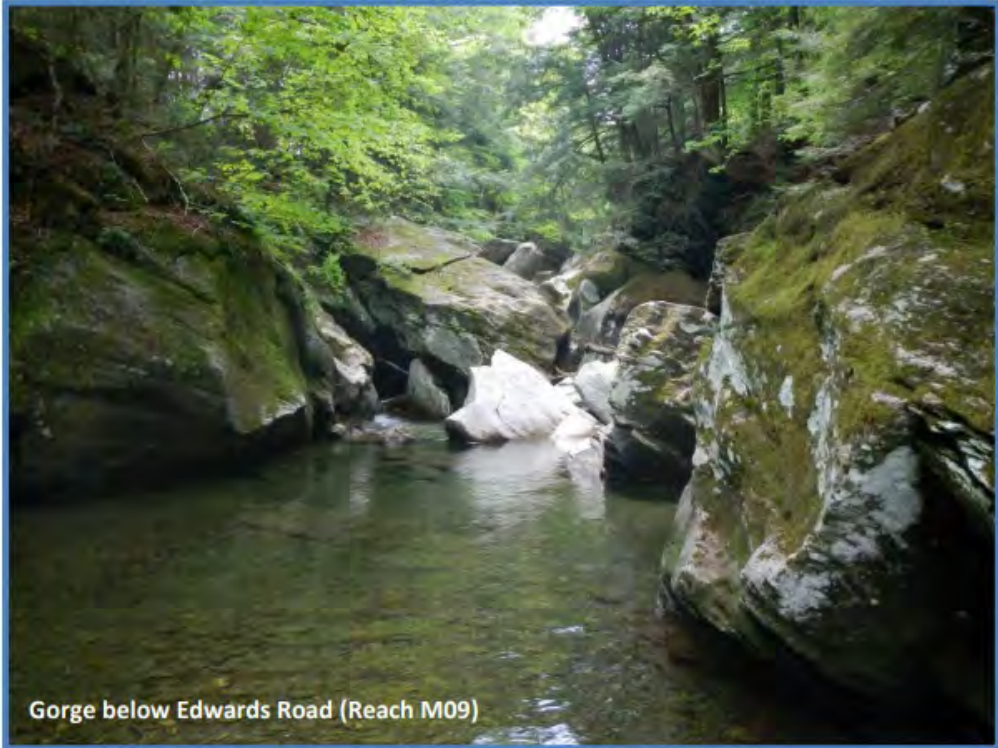
Gorge below Edwards Road (Reach M09)

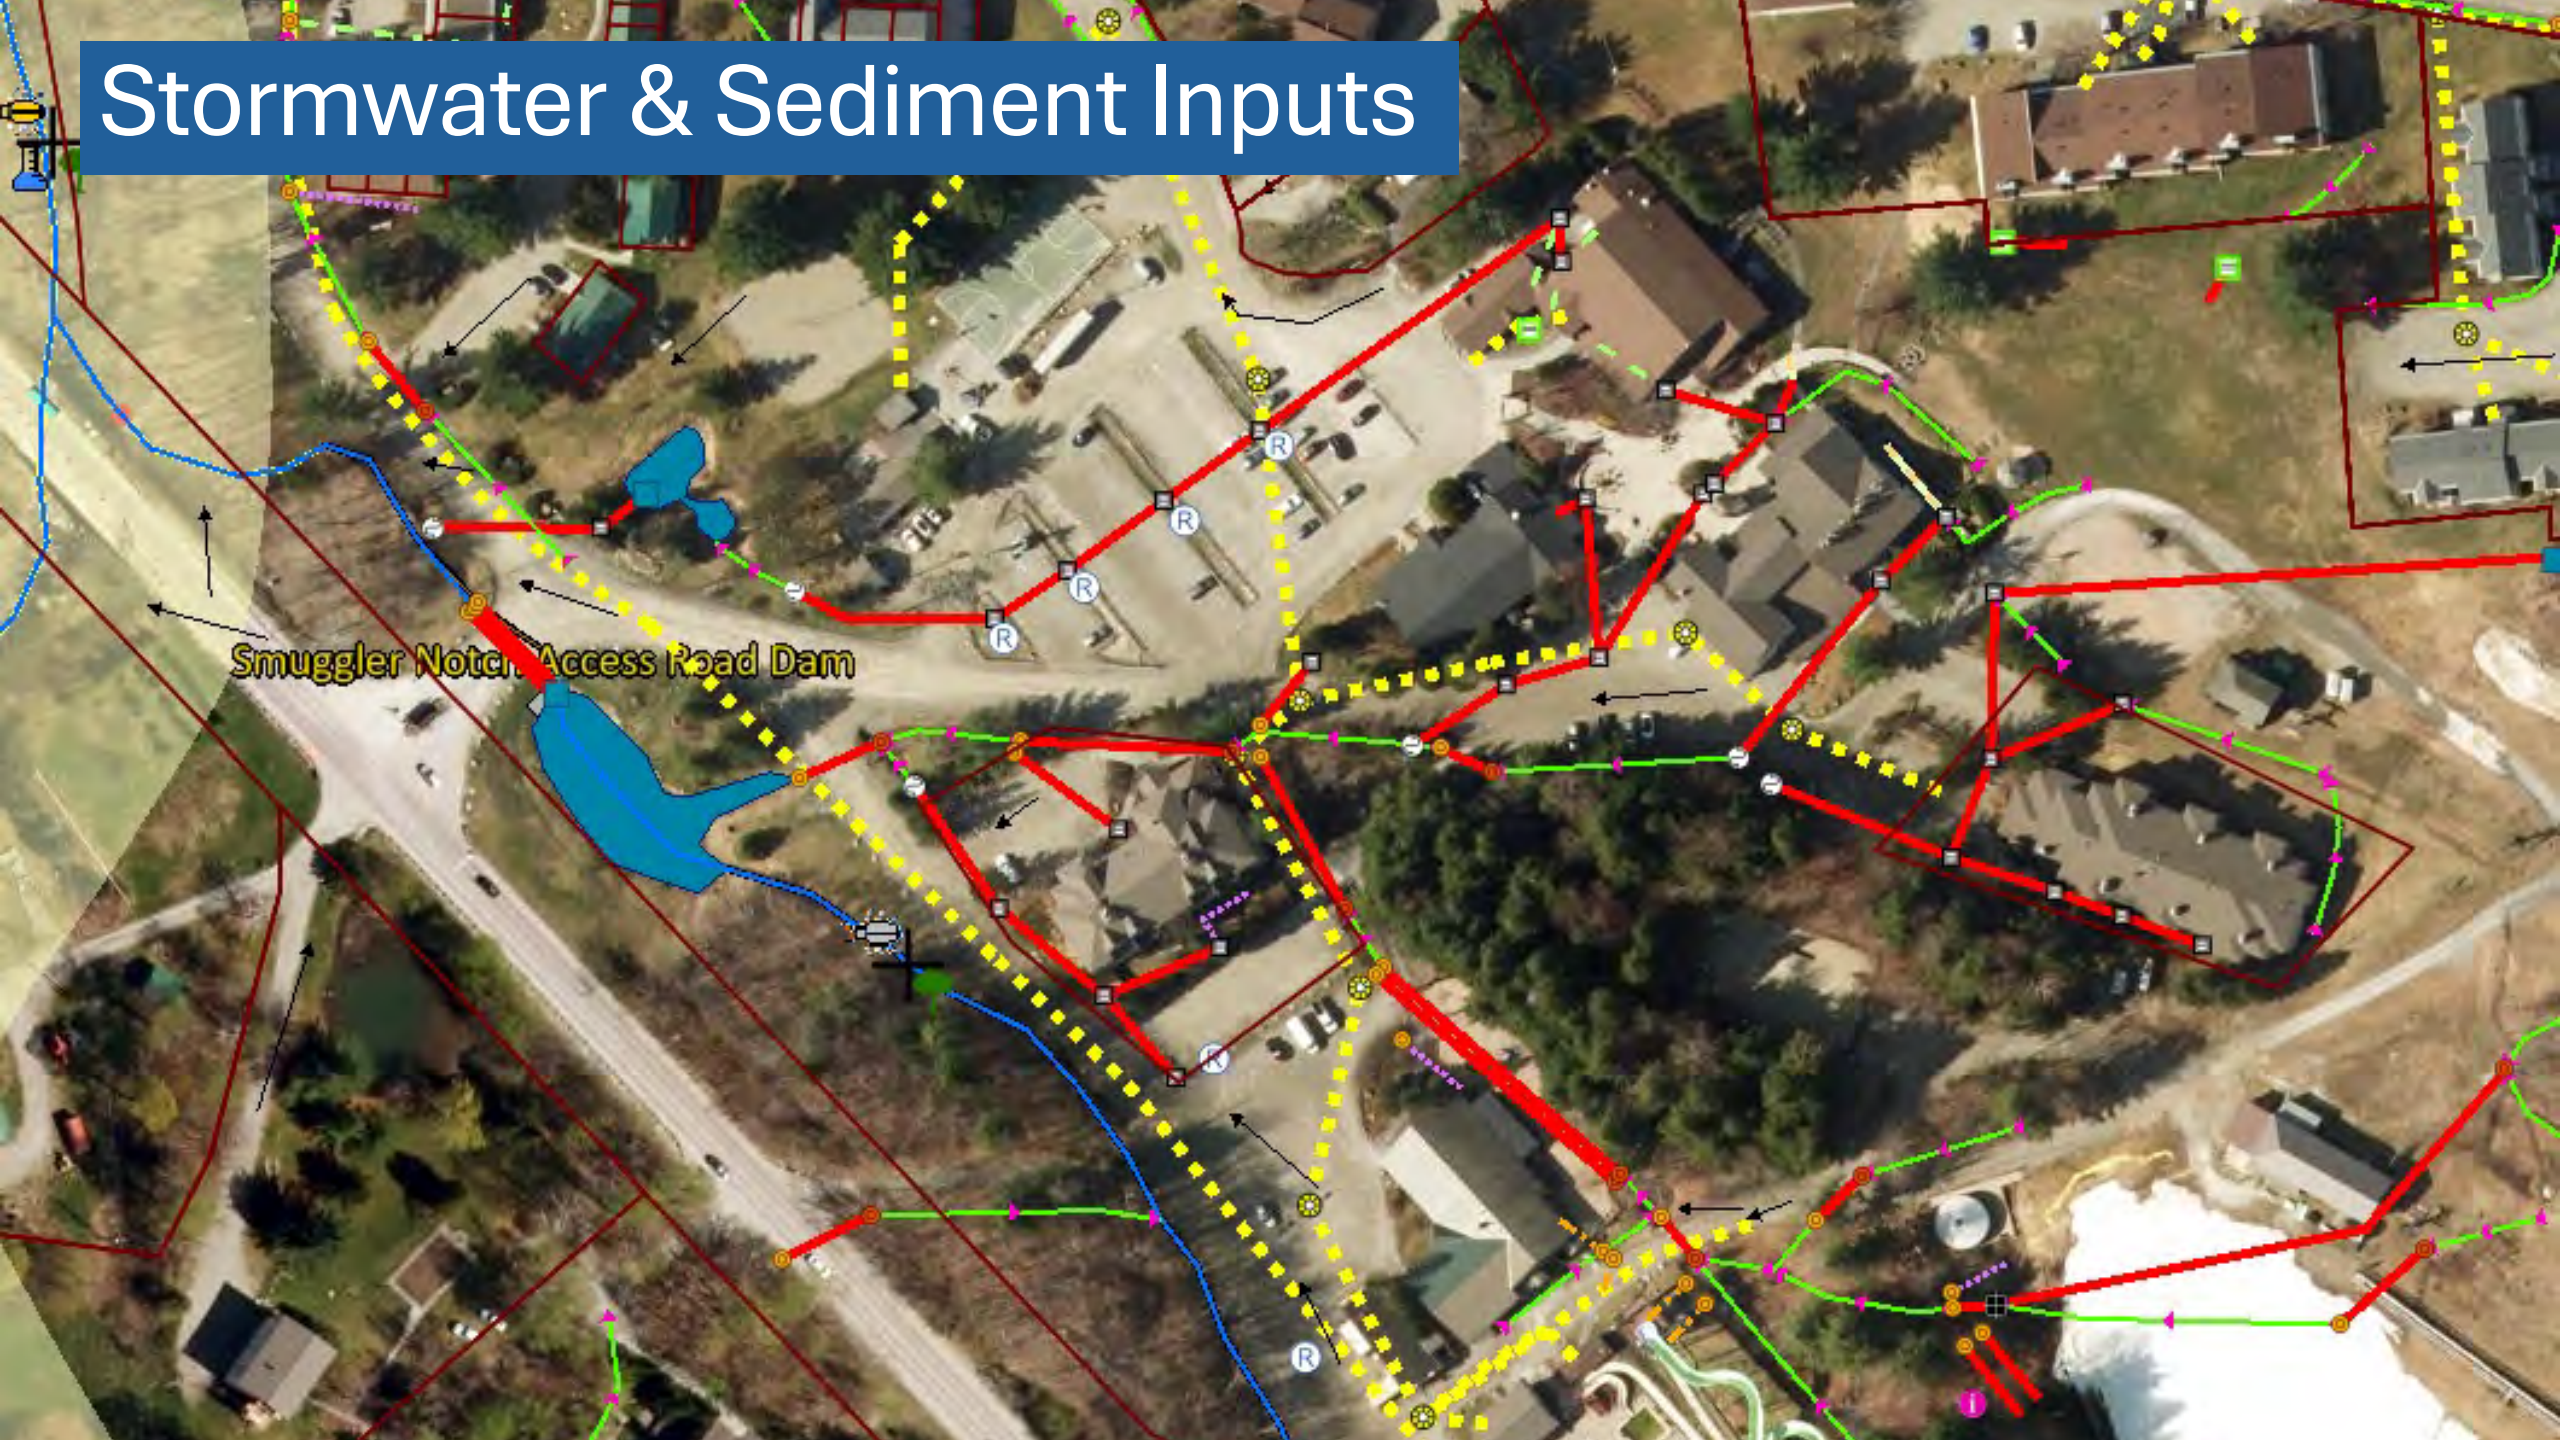
Impaired Listing

The screenshot displays a GIS interface with a map of a residential area. A yellow line on the map represents an impaired river/stream, labeled "Trib #10 to Brewster". A popup window titled "Impaired River/Stream (303d List)" provides details about this water body. The popup text states: "This surface water, described as 'Trib #10 to Brewster River (1 Mile)' has the problem of 'Impacts from landfill leachate; bio community improving; monitoring to continue' and the pollutant(s), 'IRON', have caused it to not meet the [Vermont Water Quality Standards](#). The surface water is impaired where a total maximum daily load (TMDL) is required. The complete list of 2020 impaired (303d) waters is [here](#)." Below the text are two links: "View Additional Details" and "Add to Results".

This surface water, described as "Trib #10 to Brewster River (1 Mile)" has the problem of "Impacts from landfill leachate; bio community improving; monitoring to continue" and the pollutant(s), "IRON", have caused it to not meet the [Vermont Water Quality Standards](#). The surface water is impaired where a total maximum daily load (TMDL) is required. The complete list of 2020 impaired (303d) waters is [here](#).

Map labels: Smuggler Notch Access Road Dam, Morses Mill, Trib #10 to Brewster

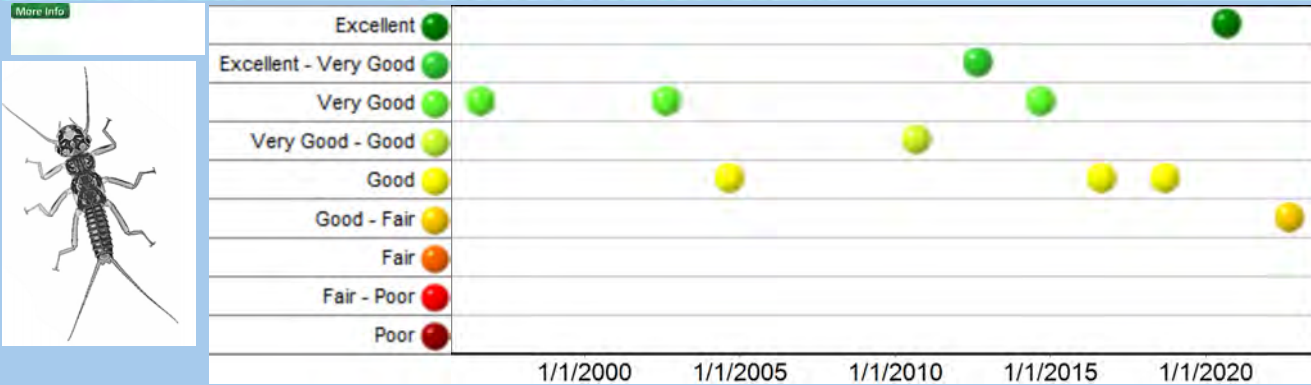
Macroinvertebrate Assessment

Macroinvertebrate population Assessments are a measure of the biological integrity of the macroinvertebrate community and an indicator of the health of the aquatic biota. (For More Details)

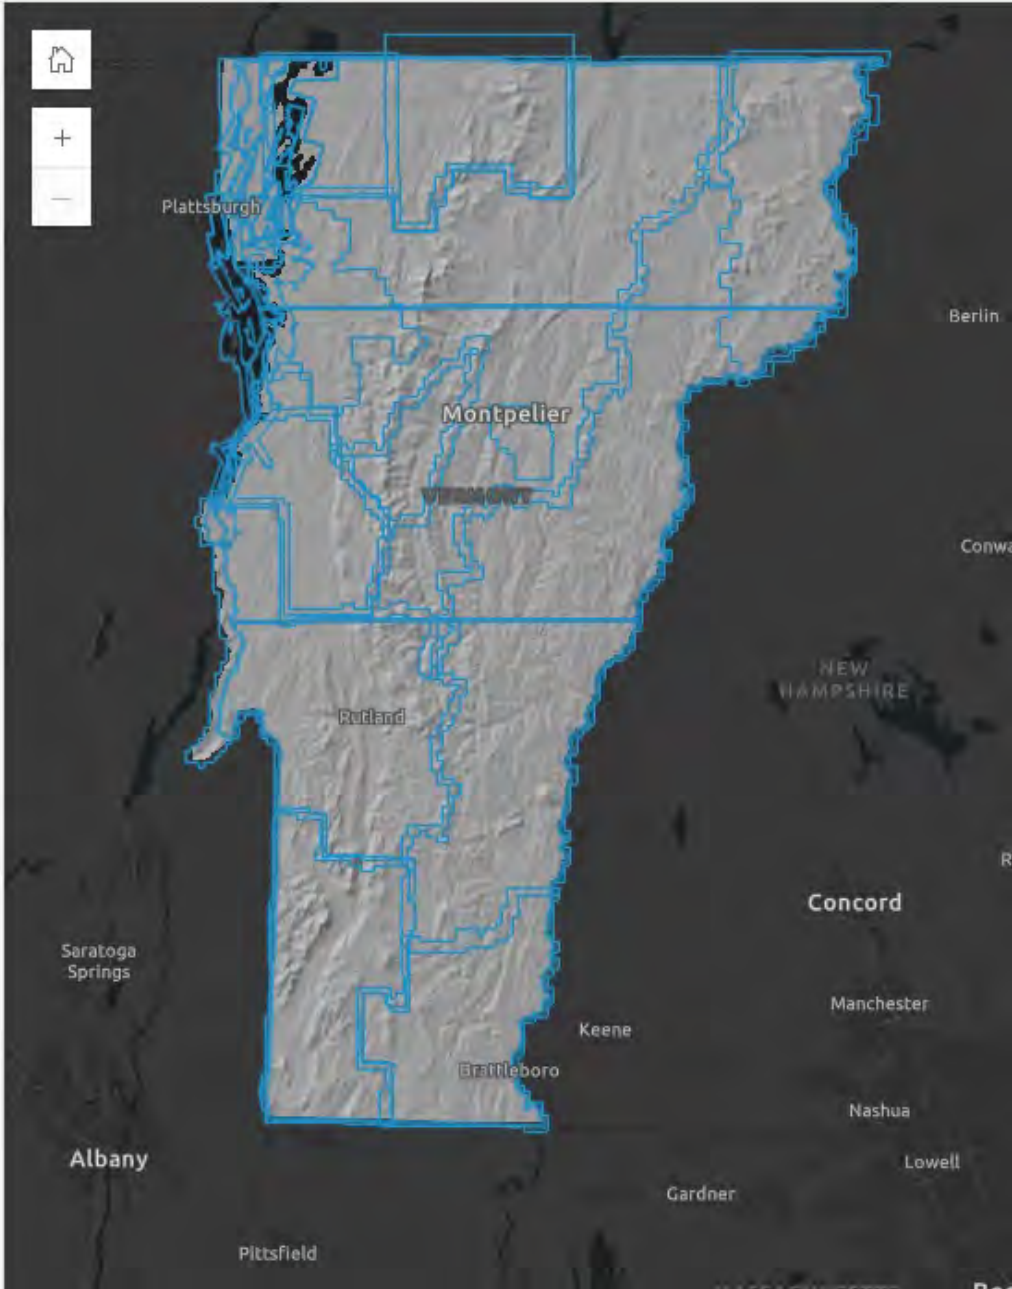
Contours (1-Foot)

1-foot contours derived from QL2 data are available to [download by tile](#) and [by municipality](#).
