Site restoration: Beyond barrier removal to restoring a diverse, functional hydrologic system

Evan Fitzgerald, Fitzgerald Environmental Associates Allaire Diamond, Vermont Land Trust

Reconnecting Rivers Workshop, December 5, 2024

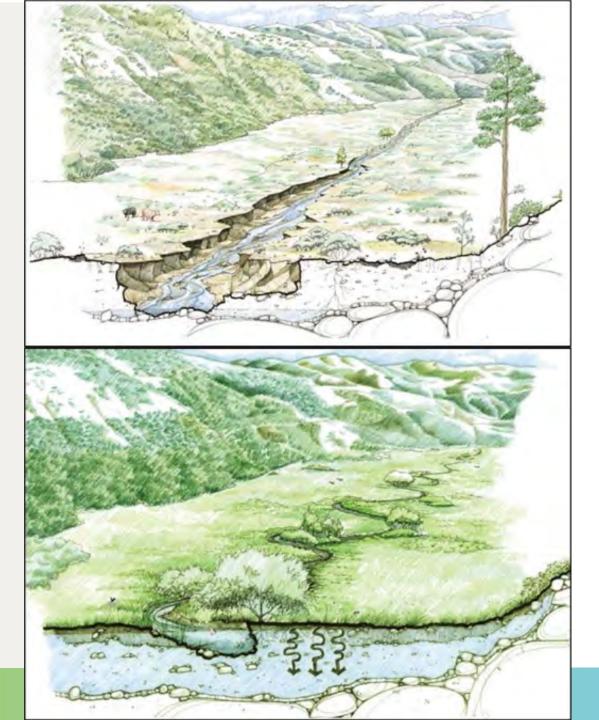
Degraded System

- Disconnected from floodplain
- Stream is straightened, incised
- High velocity = high erosion and flood damage
- Low water table and minimal groundwater
- No wetland margins

Functional System

- Floodplain connection
- Stream is sinuous
- Water flows slowly, minimal erosion
- Riparian wetlands
- Lush and diverse plant communities
- Groundwater connection

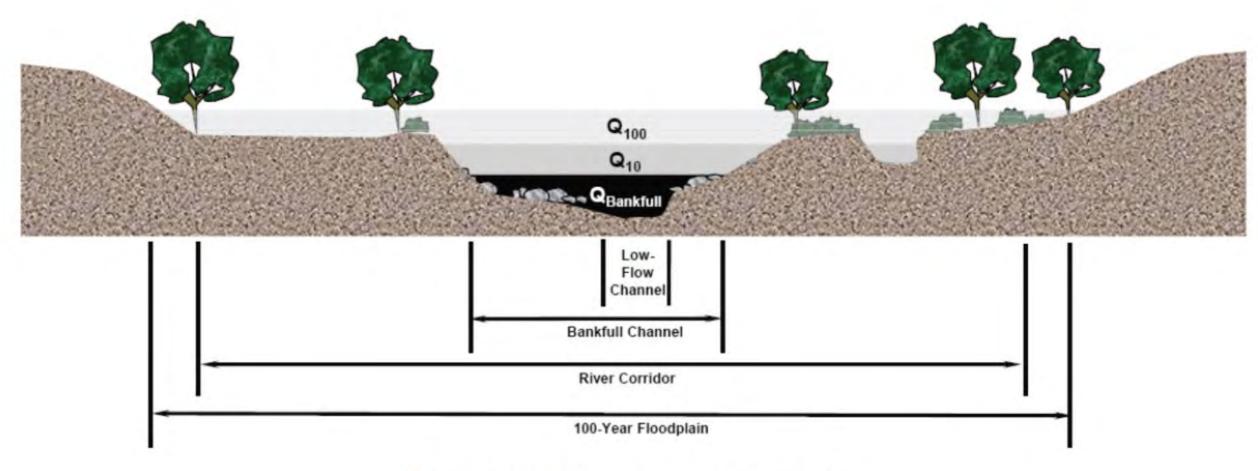
Figure 3.2: Cross section schematic. (Schiff et al., 2014)

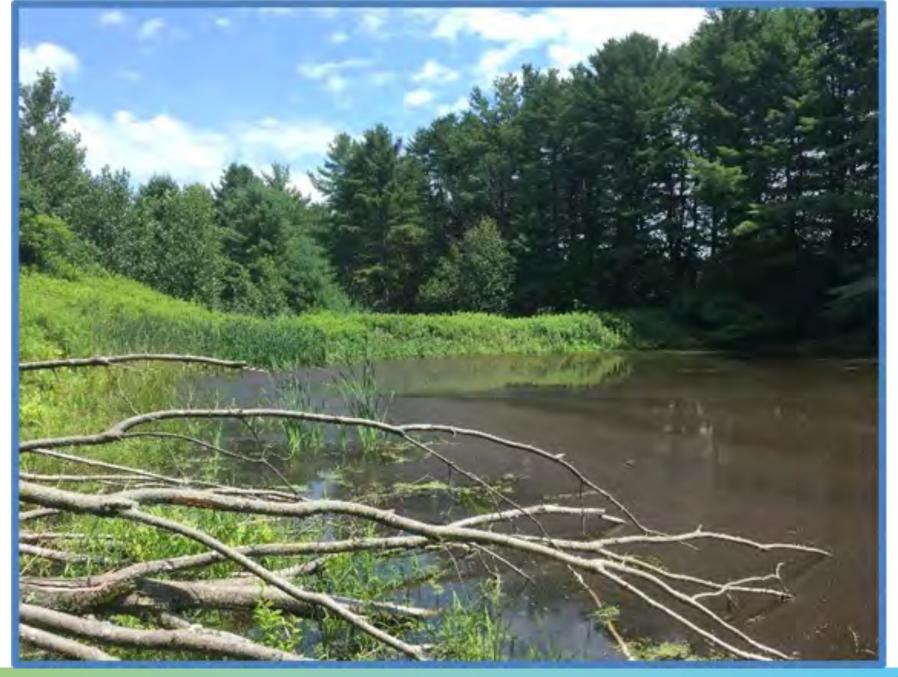
Analog Channel

- 3% Valley slope upstream
- Multi-thread channel
- Wood provides vertical stability
- Ledge outcroppings common

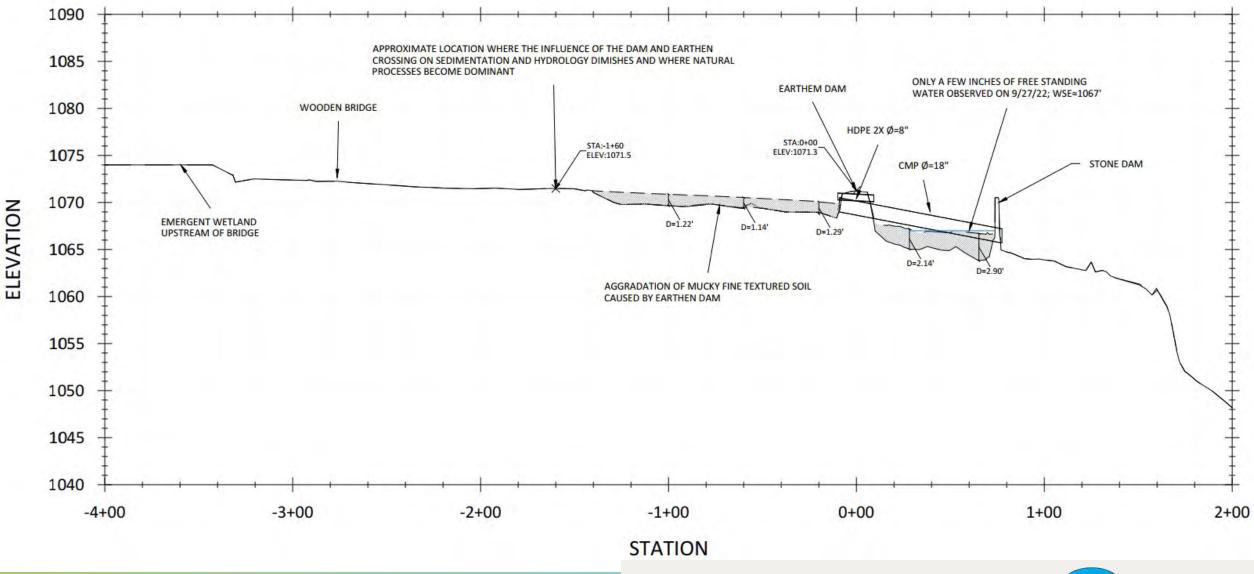
EXISTING STREAM PROFILE

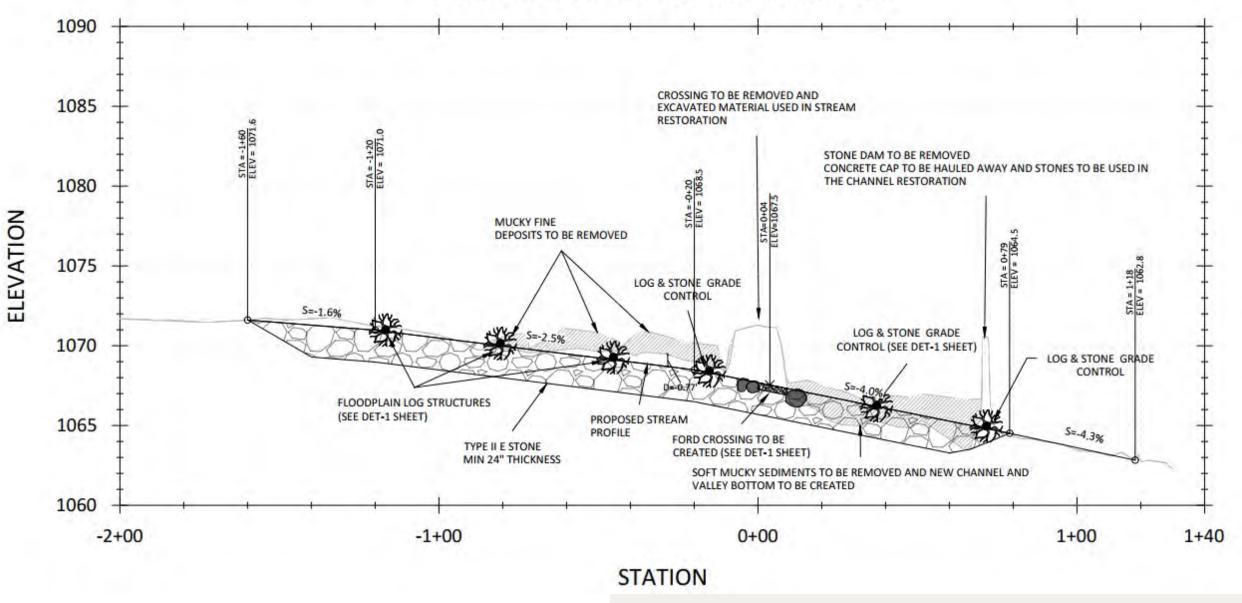
PROPOSED STREAM PROFILE

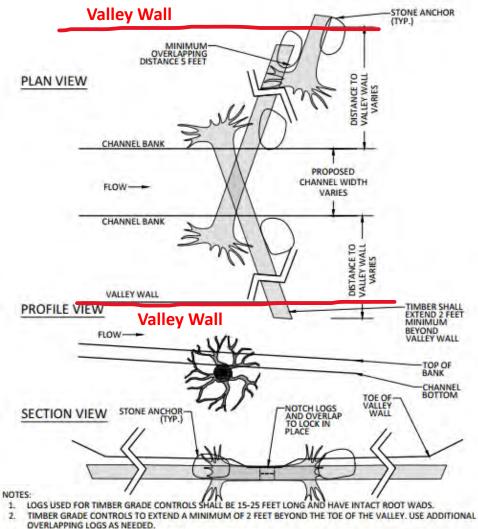
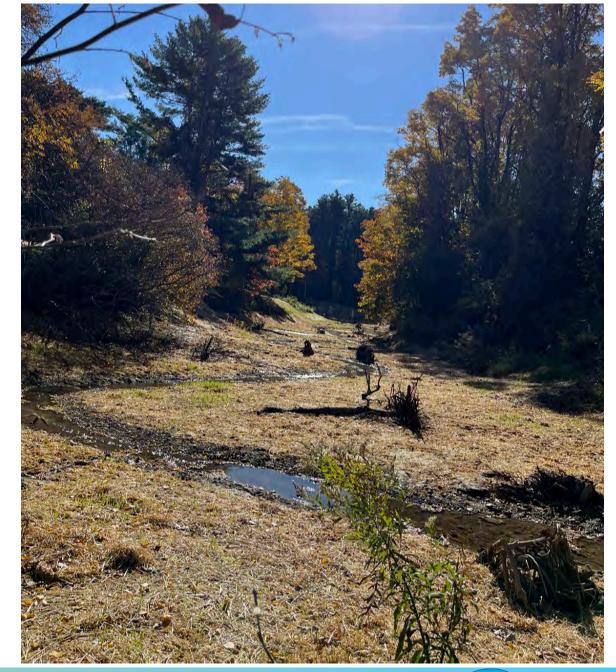
- LOGS SHALL BE NOTCHED TOGETHER BELOW THE CHANNEL 3.
- 4. TOP OF LOGS SHALL BE NO MORE THAN 2" ABOVE PROPOSED STREAM BOTTOM. LOGS SHALL BE BURIED IN FLOODPLAIN A MINIMUM OF 6", AND MAINTAIN A CONSTANT ELEVATION ACROSS VALLEY (SEE SHEET PRO-1)
- STONES SHALL BE USED TO ANCHOR THE TIMBER GRADE CONTROL STRUCTURES. STONE SHALL BE A MINIMUM DIAMETER OF 24 INCHES AND LENGTH OF 36 INCHES. STONE SHALL BE BURIED BELOW THE FLOODPLAIN ELEVATION 2/3 OF THE STONE HEIGHT AND SHALL BEAR WEIGHT ON THE DOWNSTREAM SIDE OF THE LOG TO FURTHER SUPPORT
- AGAINST EROSIVE FORCES. CARE SHALL BE TAKEN TO FULLY BACKFILL AND COMPACT SOIL AROUND LOGS AND STONES TO AVOID EROSION. 6.

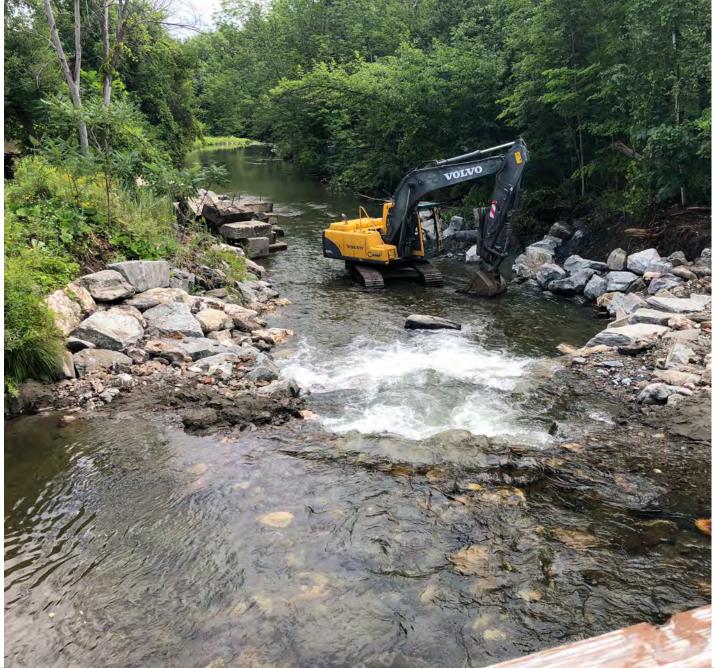
LOW-TECH PROCESS-BASED RESTORATION OF RIVERSCAPES

UtahStateUniversity POCKET FIELD GUIDE

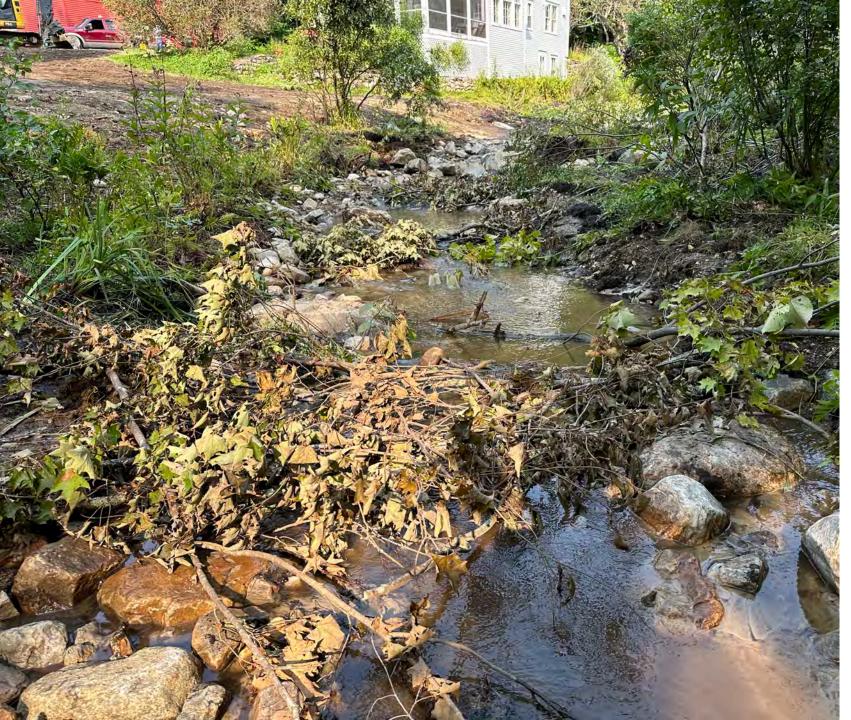
A stream comes back to life

Across the U.S. West, scientists and land managers are using beaver dam analogs (BDAs) to heal damaged streams, re-establish beaver populations, and aid wildlife. In some cases, researchers have seen positive changes in just 1 to 3 years.

Adding dams

Beaver trapping and overgrazing have caused countless creeks to cut deep trenches and water tables to drop, drying floodplains. Installing BDAs can help.

Widening the trench

BDAs divert flows, causing streams to cut into banks, widening the incised channel, and creating a supply of sediment that helps raise the stream bed.

Beavers return

As BDAs trap sediment, the stream bed rebuilds and forces water onto the floodplain, recharging groundwater. Slower flows allow beavers to recolonize.

A complex haven

Re-established beavers raise water tables, irrigate new stands of willow and alder, and create a maze of pools and side channels for fish and wildlife.

Restored stream

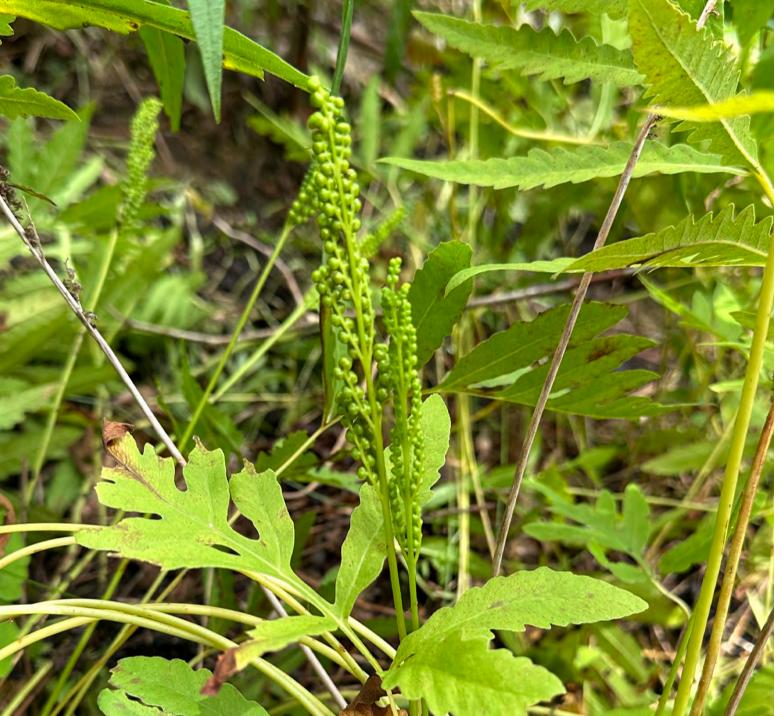
Seeding – Wetland Mix and Conservation Mix
